AJR 2002; 178:1092-1094

Case Report

Spontaneous Discharge of a Firearm in an MR Imaging Environment

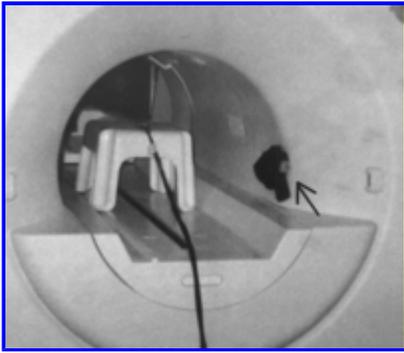
Once the officer was inside the MR suite, the gun was pulled from his hand as he attempted to place the gun on top of a cabinet 3 ft (0.9 m) away from the magnet bore. The gun was immediately pulled into the bore, where it struck the left side and spontaneously discharged a round into the wall of the room at the rear of the magnet. Fortunately, no one was injured. Although the gun struck the magnet bore, only minimal cosmetic damage occurred to the magnet itself. The MR unit had full functional capability immediately after the gun discharged. The weapon's thumb safety was reportedly engaged when the gun discharged.

An unsuccessful attempt to remove the gun from the magnet resulted in the gun being pulled to the right side of the magnet ([Fig. 1](#)). The decision was then made to power down the magnet to remove the gun.

Fig. 1. —Photograph shows gun (*arrow*) stuck on right side of MR imaging magnet bore.

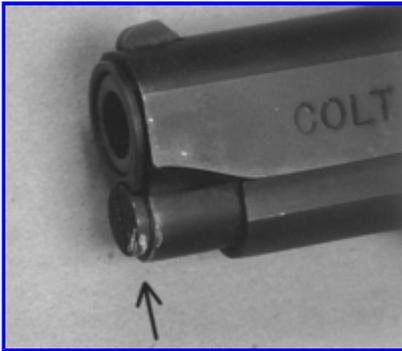
Fig. 2B. —Photographs of 1991 A-1.45 caliber semiautomatic pistol (Colt's Manufacturing, Hartford, CT). Muzzle of gun shows small amount of white paint (*arrow*) where gun impacted magnet.

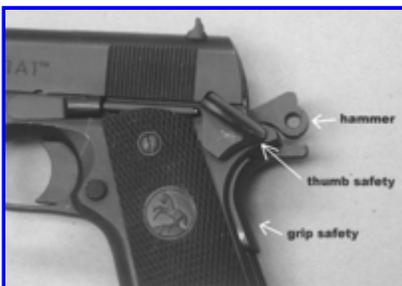
Fig. 2C. —Photographs of 1991 A-1.45 caliber semiautomatic pistol (Colt's Manufacturing, Hartford, CT). Hammer, thumb safety, and grip safety of gun are shown. Gun is in cocked and locked position with hammer cocked and thumb safety turned on to prevent hammer from striking firing pin. This is condition in which gun was recovered from magnet.

At the time the weapon discharged, it was reportedly in a cocked and locked position; that is, the hammer was cocked and the thumb safety was engaged to prevent the hammer from striking the firing pin. A live round was in the chamber. (Many people who choose this weapon for personal protection will carry it in this manner because it allows them to quickly fire the weapon if needed.)

When the firearm was removed from the magnet, the gun was still in a cocked and locked position. An empty cartridge was found in the chamber. The presence of an empty cartridge in the chamber is highly unusual. If the thumb safety were not engaged and the weapon fired normally by depressing the trigger, the normal backward recoil of the slide should have automatically ejected the empty cartridge, and a new live round should have automatically been chambered. As discussed earlier, the thumb safety performs two functions: it prevents the sear from releasing the hammer, thereby preventing the hammer from striking the firing pin; it also locks the slide in place, preventing retrograde motion of the slide and automatic ejection of the empty cartridge. Thus, the presence of an empty cartridge in the chamber confirms that the thumb safety was engaged at the time the gun was fired. Given that the thumb safety was engaged when the gun discharged, it is also likely that the normal trigger and hammer mechanism of firing the gun was bypassed because the thumb safety would have also prevented release of the hammer.

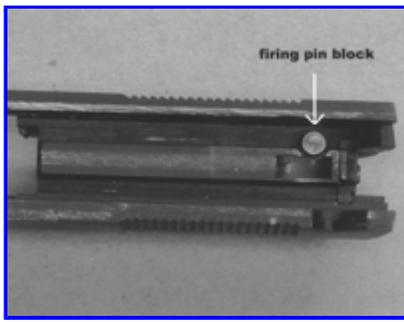
Fig. 2D. —Photographs of 1991 A-1.45 caliber semiautomatic pistol (Colt's Manufacturing, Hartford, CT). Disassembled gun with view of slide interior from below shows firing pin block.

The gun likely discharged as a result of the effect of the magnetic field on the firing pin block. The firing pin block was probably drawn into its uppermost position by force of the magnetic field. The firing pin block has to overcome only light pressure from a relatively small spring to release the firing pin. The pistol was likely drawn into the magnetic field so that the muzzle struck the magnet's bore first. With the firing pin allowed to move freely in its channel, the force of the impact on the muzzle end was sufficient to cause the firing pin to overcome its spring pressure and move forward to strike the primer of the chambered round.

One can look at the sequence of events preceding the discharge of the weapon and see several points at which the incident could have been prevented. When the officer came in with the gun, it should have been immediately secured in a safe location, even before the officer changed for the examination. The technologist, knowing the officer had a firearm, should have instructed him that under no circumstances could he bring the weapon into the MR suite. Also, the technologist should have been monitoring the officer more closely to make sure he did not enter the MR suite with the weapon. Signs should have been posted at that site, if they were not already there, warning the public of the dangers of approaching the magnetic field of the MR imager with implants, metallic devices, or objects such as firearms.
