AJR 2002; 178:1092-1094

Case Report

Spontaneous Discharge of a Firearm in an MR Imaging Environment

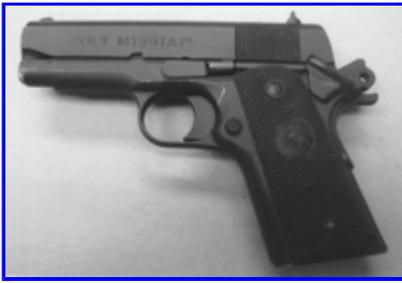
Fig. 2A. —Photographs of 1991 A-1.45 caliber semiautomatic pistol (Colt's Manufacturing, Hartford, CT). Actual gun involved in incident is shown.
